Performance Assessment of Two Different Aviation CARC Coating Systems on Steel When Cadmium Plating Is Eliminated

ARL-TR-4136

June 2007

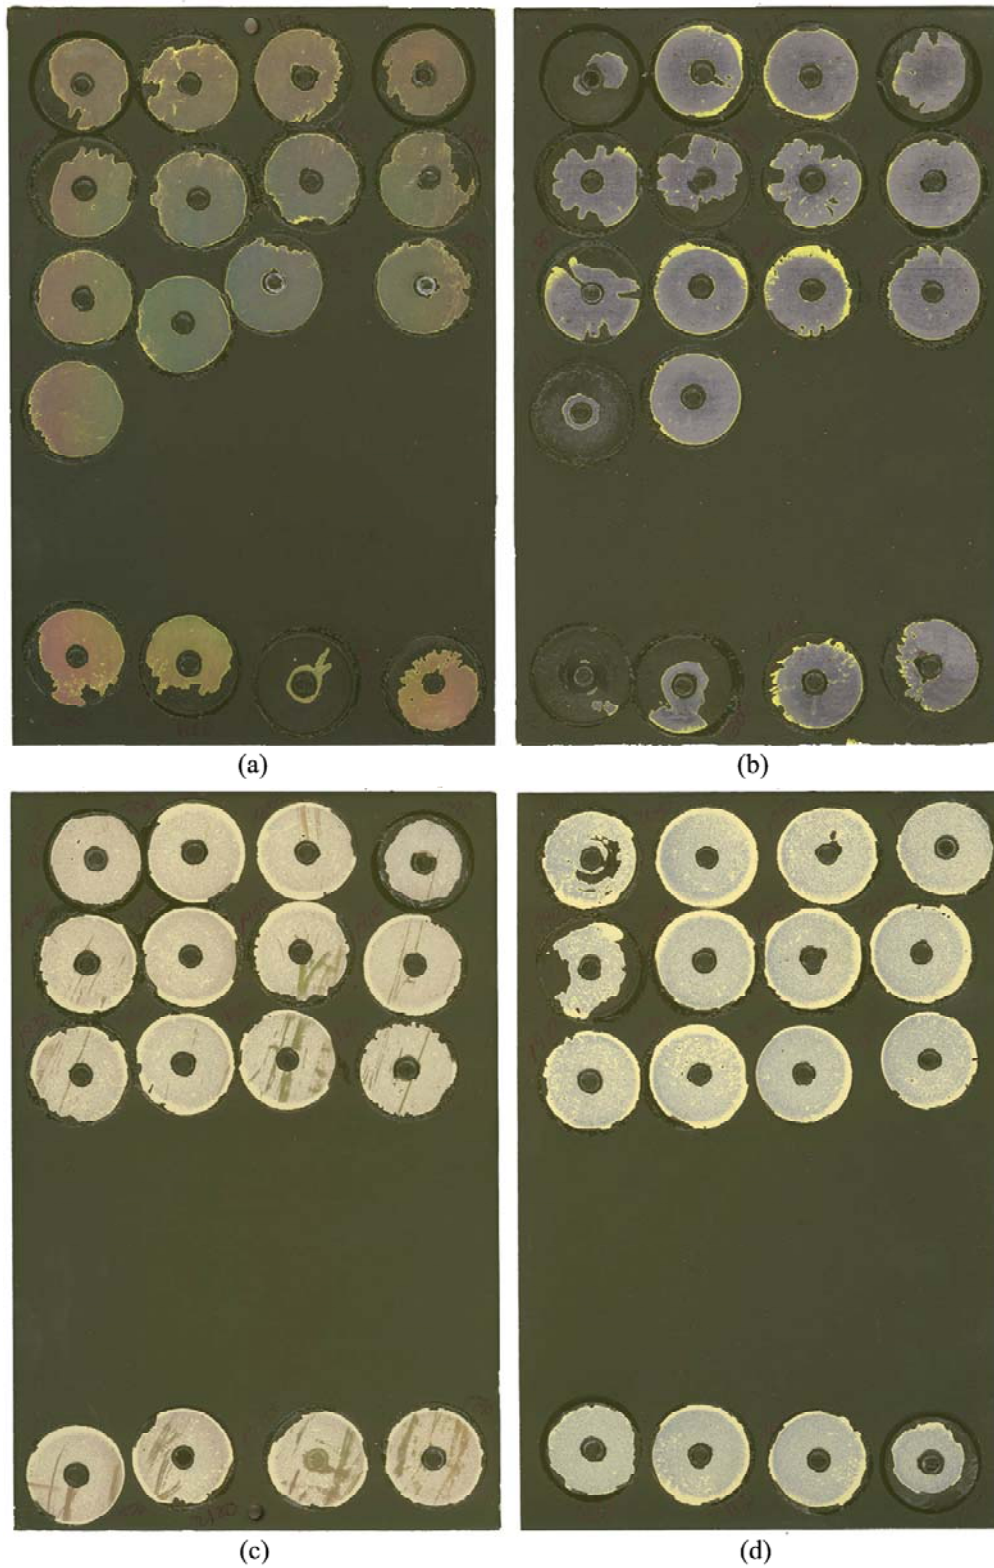
Figure 20. Pull-off failure modes for coating systems (a) 1, (b) 2 on unblasted mill-finish steel, (c) 3, and (d) 4 on unblasted mill-finish steel.

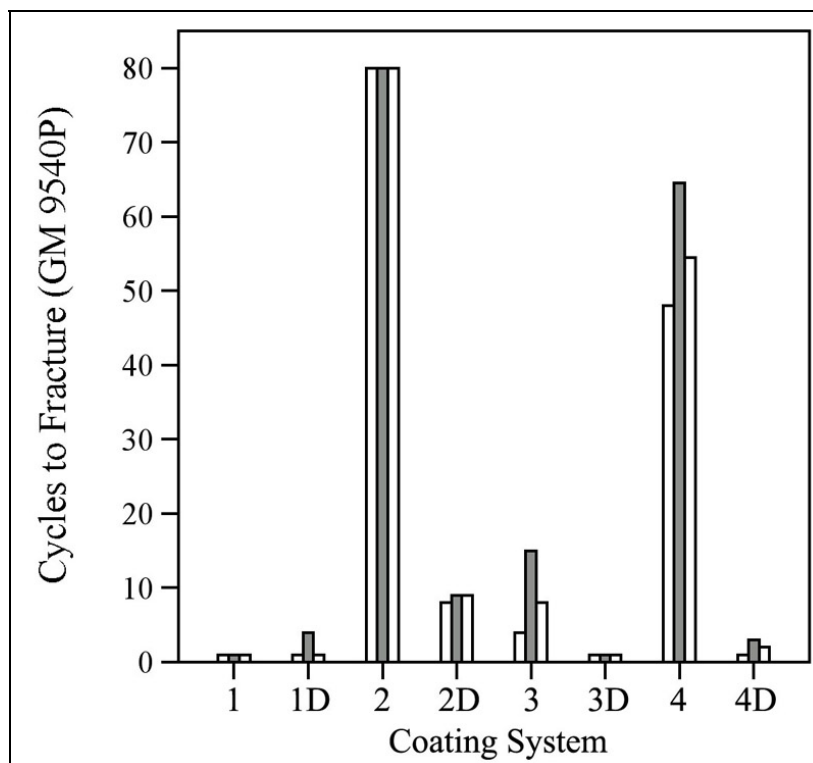
Figure 21. Coating-system damage vs. GM 9540P cycles to C-ring fracture.

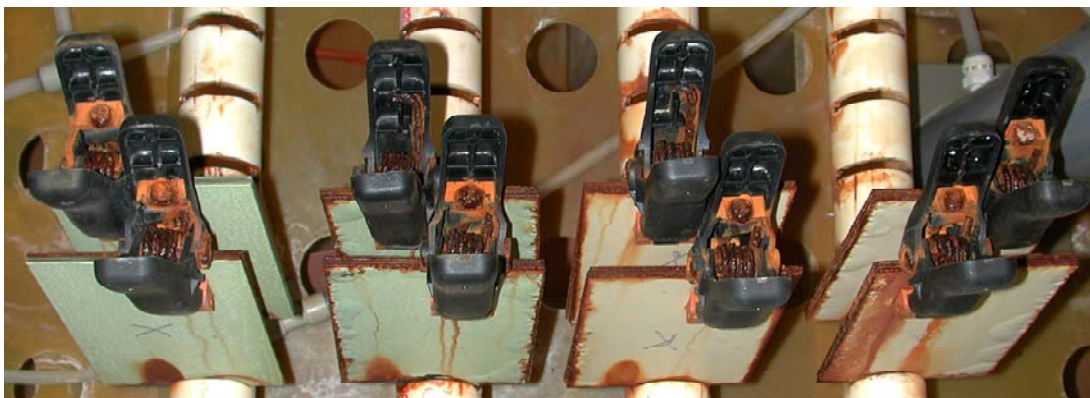
Figure 22. Clamped, unscribed crevice assemblies at 80 cycles of GM 9540P showing relative damage among coating systems 1–4 (from left to right).

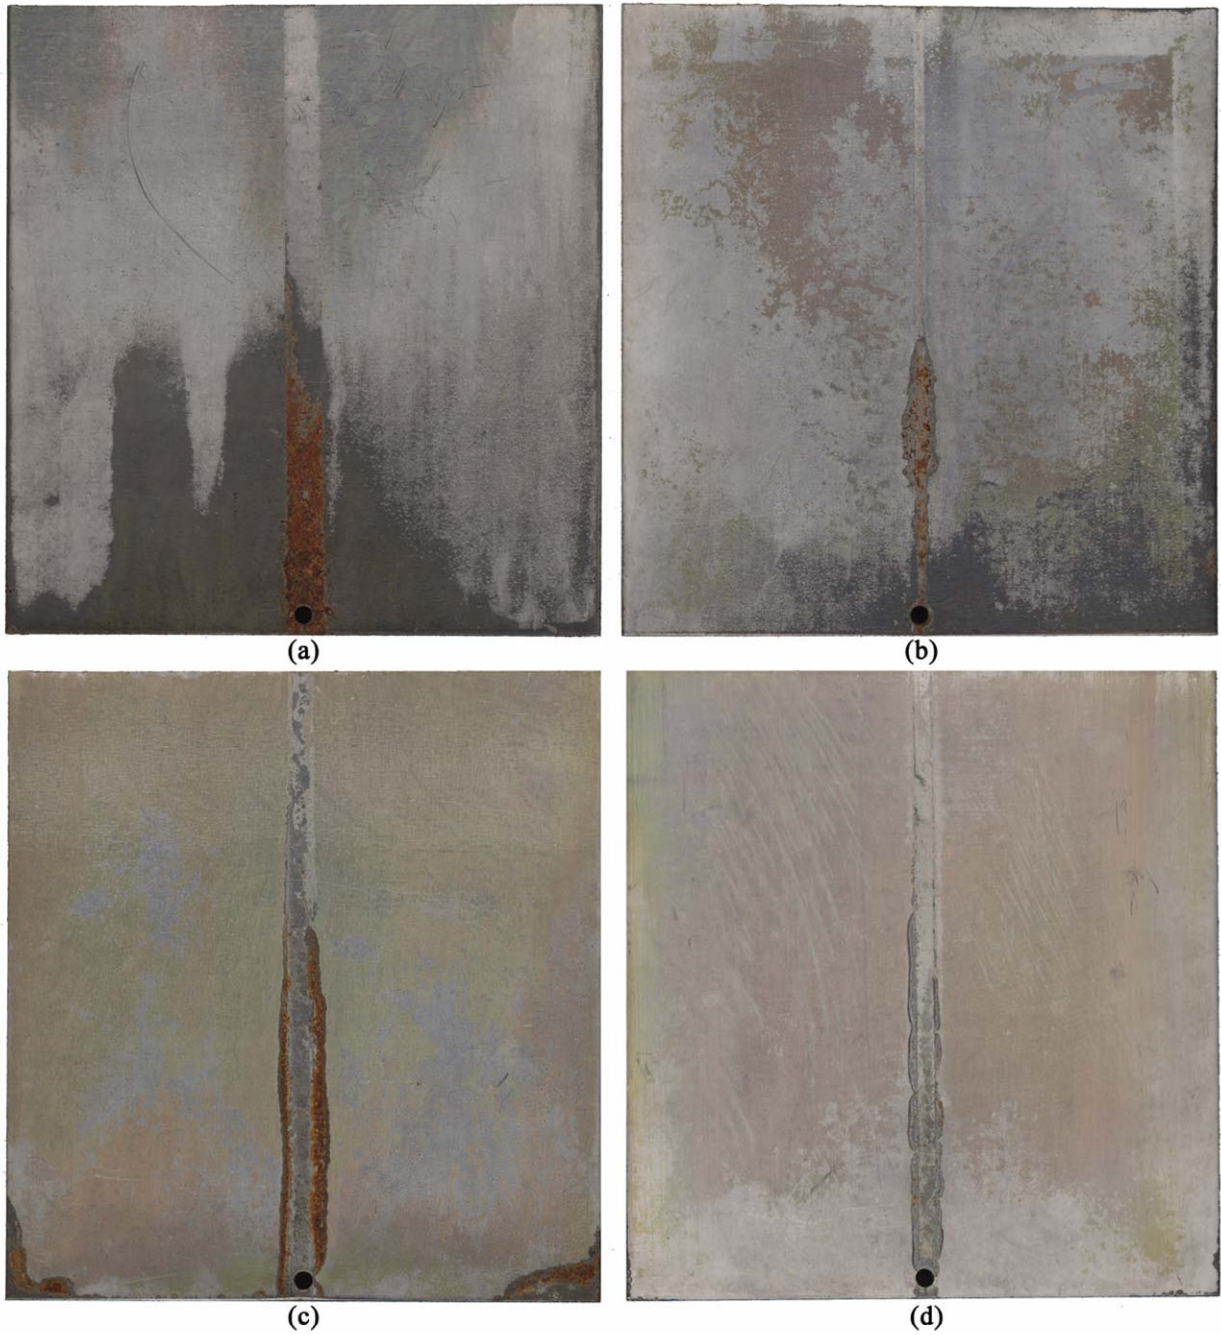
Figure 24. Throwing-power test panels chemically stripped to reveal variations in Cd-plating uniformity: (a and b) panels failing earliest (eight GM 9540P cycles) with obvious Cd-depleted regions and (c and d) panels lasting longest (395 GM9540P cycles) with complete Cd coverage and better uniformity of the chromate layer (magnified 0.75 \times).

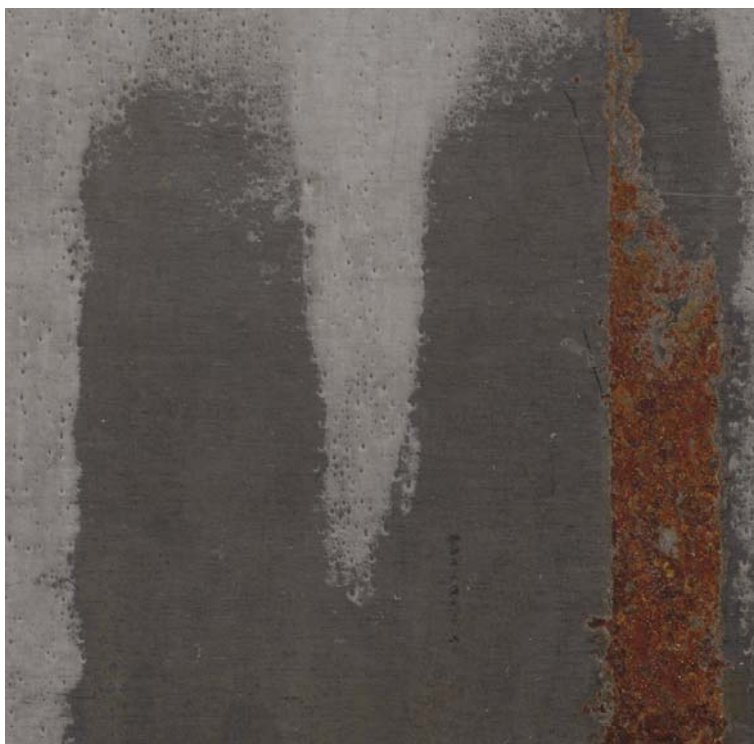
Figure 25. Magnified (1.5 \times) view of an eight-cycle, failed throwing-power test panel (light grey streaks show Cd distribution, bare dark grey steel substrate are areas with no Cd, and the rusted region corresponds to the original throwing-power masked area [Cd free]).

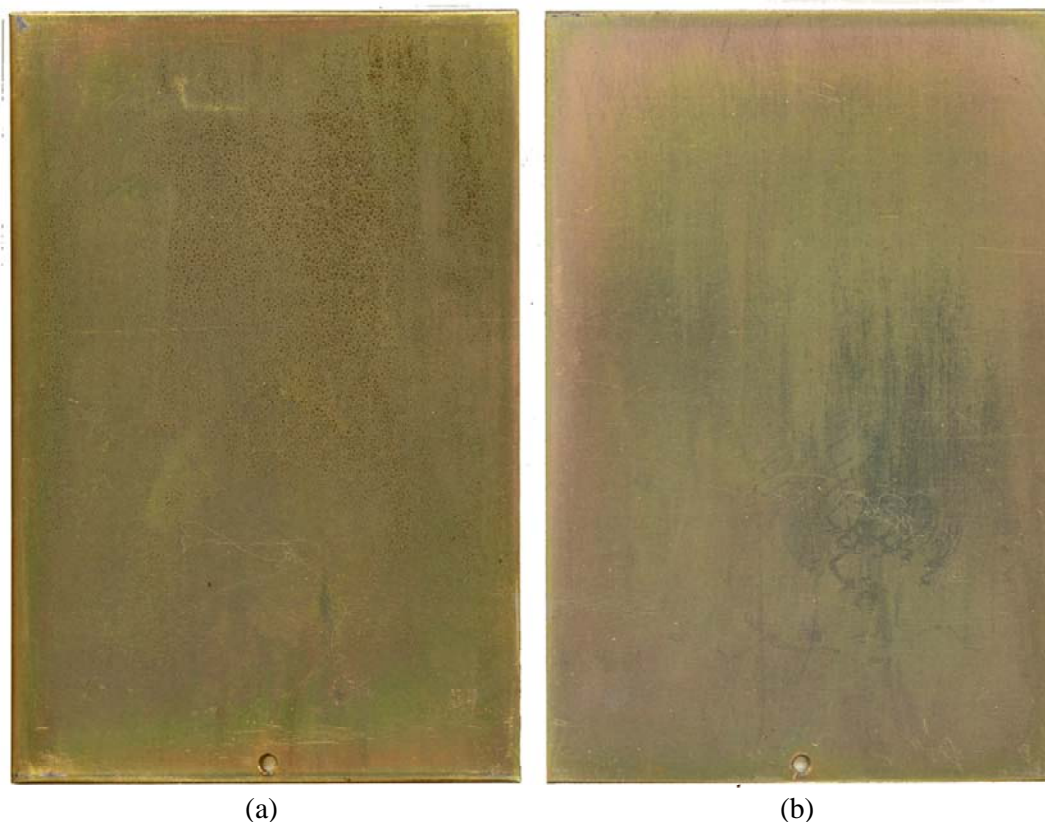
Figure 26. Variations among cadmium plated test panels showing (a) mottling and (b) uniform conditions.

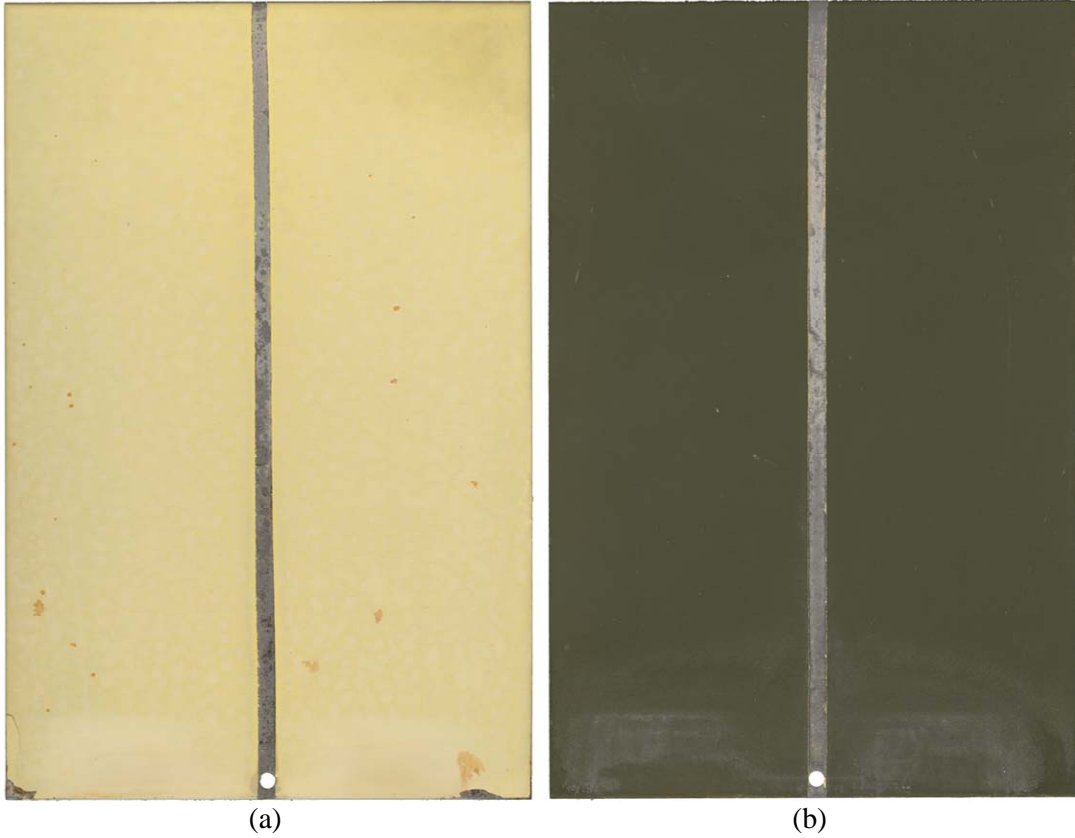
Figure 27. Coatings lifting and peeling on Cd-plated, 0.125-in masked panels after 395 cycles of GM 9540P with (a) MIL-PRF-23377C and (b) MIL-PRF-23377N with MIL-DTL-64159.

- For throwing-power panels that lasted beyond 200 GM 9540P cycles, lifting and peeling of the organic coating system extended the cycles to red rust for the panels by exposing fresh areas of Cd.

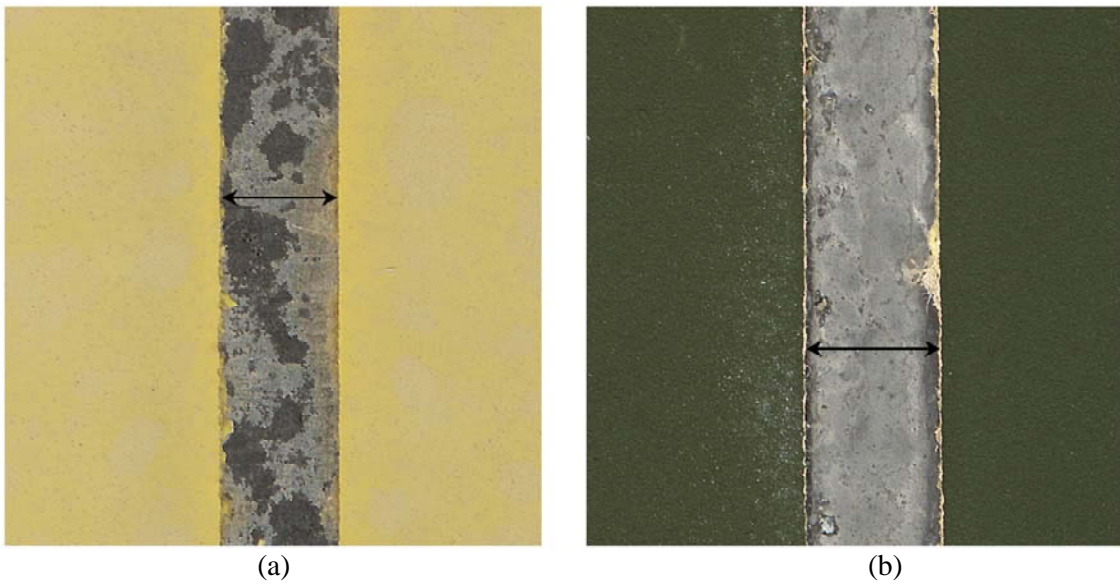
Figure 28. Magnified images (6 \times) of Cd-plated, 0.125-in masked panels after 395 cycles of GM 9540P with (a) MIL-PRF-23377C and (b) MIL-PRF-23377N with MIL-DTL-64159 (arrows indicate areas where coating is lifting).

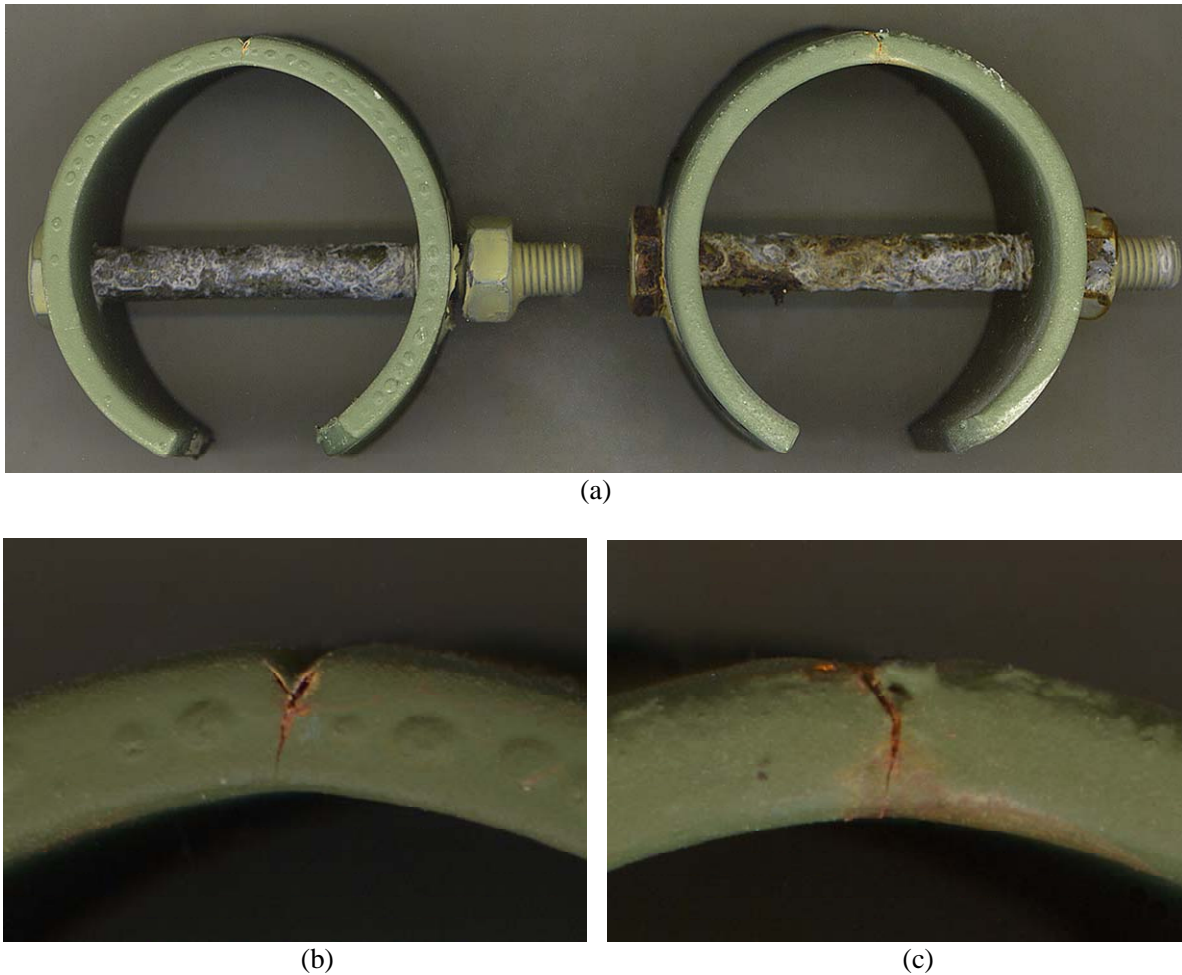
Figure 29. Corrosion ingress for undamaged coating system 4 C-rings (a, left) near-notch side blistering at 4 cycles GM 9540P, (a, right) near-notch rust staining of edge at 48 GM 9540P cycles, (b) side blistering (7 \times magnification), and (c) rust staining near edge (7 \times magnification).
